S. Biron Ebell and Gary Adams

York Factory's Octagon A Multifaceted CRM Challenge

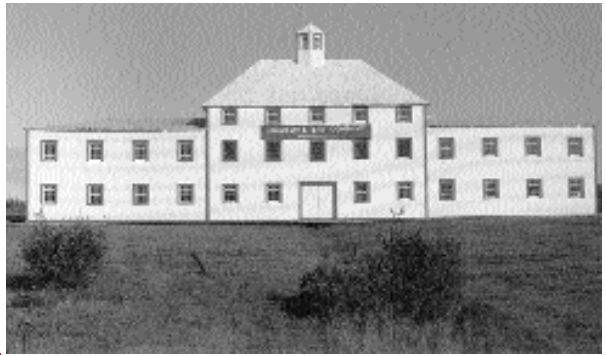
York Factory Depot. The three story section in the centre was constructed in 1831. The sections on each side were constructed in the following two years. Photo by S. Biron Ebell.

The most visible and spectacular aspect of York Factory National Historic Site is the over 150-year-old Hudson's Bay Company warehouse and packing room, called the Depot. This building, imposing in its scale even when constructed, became the central focus of the entrepot's activities over time, consolidating almost all of them under one roof.

Both time and the environment have left their marks on the Depot. As part of a large trading centre, today it stands alone on unconsolidated, saturated, permanently frozen river silts on the left bank of the Hayes River, about 8 km from Hudson Bay in Manitoba. Its proximity to Hudson Bay assures that winters are long and cold, and the summers short and wet. The Depot is large, measuring about 30 metres square, with an internal courtyard measuring 11 by 16 metres. This wooden frame building was constructed in sections over a seven-year period beginning in 1831.
